The Impact of the Earthquake in Racha on the Enguri Arch Dam and the Adjacent Area

ABSTRACT

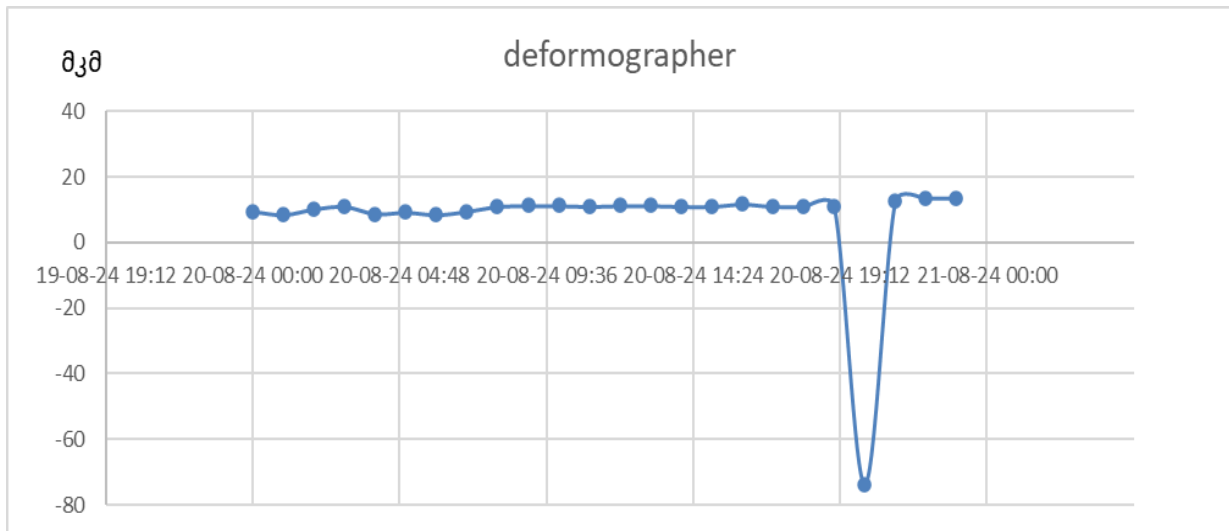
Fig. 2.

As shown in Fig. 2, the deformation caused by the earthquake on the fault reaches approximately 80 microns, which is a significant deformation (annual deformation = 120 microns). However, the edges quickly return to their original state, meaning that no residual deformation remains. Thus, the earthquake-induced wave caused the fault to shift.

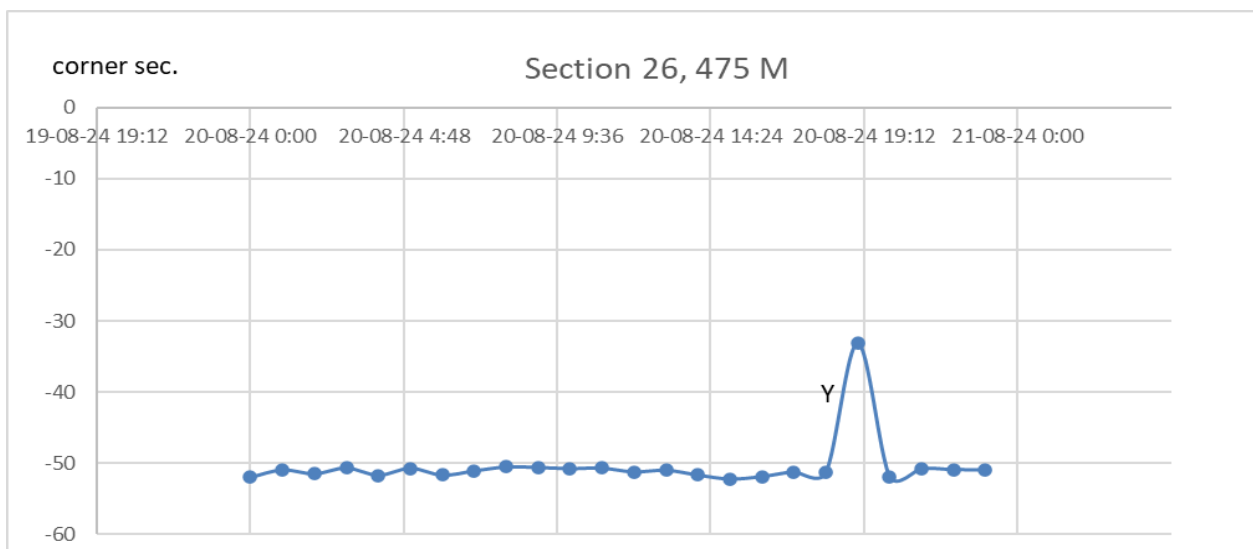
Fig. 3 shows the deformation caused by the earthquake on the dam, specifically at the 475 m elevation in section 26. The value of the deformation does not exceed 18 arc-seconds. Similarly to the fault, the observation point returned to its original state after some time, indicating no residual deformation here either

In conclusion, we can state that the earthquake in Racha did not cause any significant changes to the dam or the fault.
