Some Results of an Expeditionary Study of the Tornado Distribution Area in Kakheti on June 25, 2024

Some results of an expeditionary study of the tornado distribution area in Kakheti on June 25, 2024 are presented. The team of researchers visiting the Alaverdi Cathedral, had a meeting with His Eminence, Bishop of Alaverdi, Metropolitan David. The damage to the Alaverdi Cathedral and its surroundings was discussed in detail. Important information has been received regarding this issue. Further research was continued in the area surrounding the Alaverdi Cathedral and in the direction of the villages of Kvemo and Zemo Alvani. The probable place of origin of the tornado and the trajectory and area of its spread were determined. The damage caused by the tornado on the propagation trajectory was studied. More detailed studies of this natural phenomenon are planned in the near future.

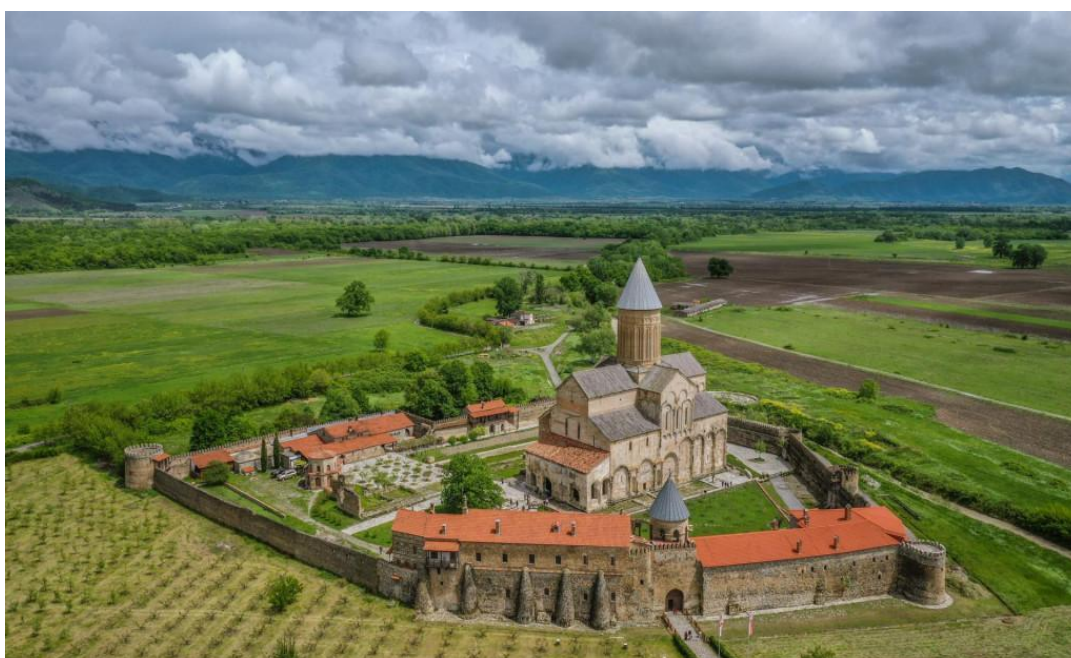
Fig. 1. Alaverdi - Cathedral and Monastery.

Alaverdi - Cathedral and Monastery is located in the Kakheti region of Akhmeta municipality, on Alazani valley, near the village of Alaverdi, 20 km from Telavi (Fig. 1). The temple is one of the largest church buildings in Georgia. Its height including dome is above 50 meters. The complex includes buildings: Alaverdi St. George Cathedral, defensive wall, chapel, Peikar-Khan's palace, wine cellar and bath.

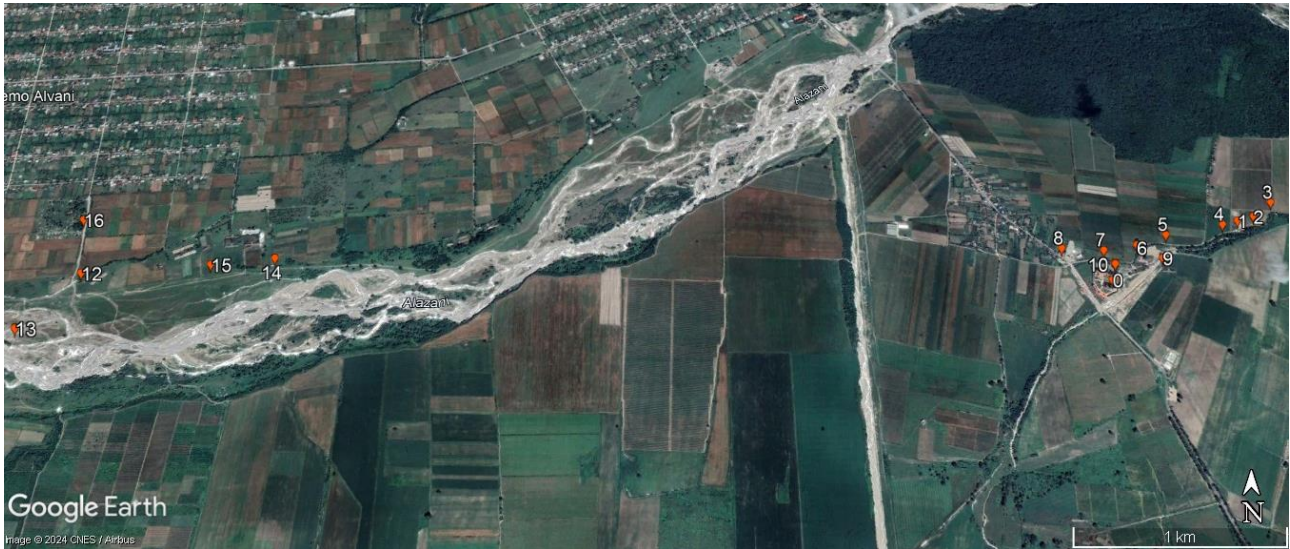
Fig. 2. Some locations the tornado distribution area in Kakheti on June 25, 2024.

In Fig. 2 and Table 1 information about some locations the tornado distribution area in Kakheti on June 25, 2024. Table 1 also provides information on damage to various objects along the tornado's path.

Table 1. Coordinates of locations the tornado distribution area in Kakheti according to Fig. 2.

Point N	Lat, °N	Long, °E	H, m, a.s.l.	Comment
0	42.03236	45.37742	446	Center dome of the Cathedral.
1	42.0356	45.38649	437	Agricultural cold storage farm. A large tree branch was broken and part of the building's roof collapsed.
2	42.03584	45.38761	435	To the direction of the tornado movement.
3	42.03664	45.38904	435	To the direction of the tornado movement.
4	42.03538	45.38543	437	Roof remains found.
5	42.0348	45.38156	439	Road to the cold storage farm (behind the Cathedral).
6	42.03424	45.37951	440	Damaged shed roof.
7	42.03395	45.37731	441	A damaged tree behind the Cathedral.
8	42.03405	45.37462	443	Shop between the cathedral and the village Alaverdi.
9	42.03354	45.38095	440	Farm with badly damaged roof next to the Cathedral.
10	42.03321	45.37783	443	Cemetery. Damaged trees and broken tiles. Next to the Cathedral.
11	42.03328	45.37783	443	Cemetery. A possible place where the cross fell.
12	42.03272	45.31199	466	Farm in the Zemo Alvani. Farmer - Chikhoshvili Khvicha.

13	42.02984	45.30888	466	Approximate location of tornado formation.
14	42.03351	45.32413	458	Damaged house under construction at the end of a farm in Zemo Alvani.
15	42.03317	45.32011	461	A heavily damaged farm roof in the path of a tornado.
16	42.03565	45.31116	467	The temple at Zemo Alvani, near the cemetery, is one of the tornado's travel points.

In particular, as follows from Fig. 2 and Table 2, distance from the approximate location of tornado formation to the center dome of the Cathedral is ≈ 5.7 km. The greatest distance we found from the site of tornado formation to point 3 is approximately 6.67 km. Thus, even without taking into account the tortuosity of the trajectory, the tornado covered a distance of at least 7 km. This fact, according to available data, is quite rare for the continental part of Georgia.

Along with the covering of the central dome of the cathedral, the tornado tore off the cross, which was found approximately 0.11 km from this dome on the territory of the cemetery (Fig. 2, Tables 1 and 3).

Other objects in the vicinity of the Cathedral were also damaged. So, for example, distance from the center dome of the Cathedral to agricultural cold storage farm (Point 1) is ≈ 0.83 km, and to farm with badly damaged roof (Point 9) is ≈ 0.32 km.

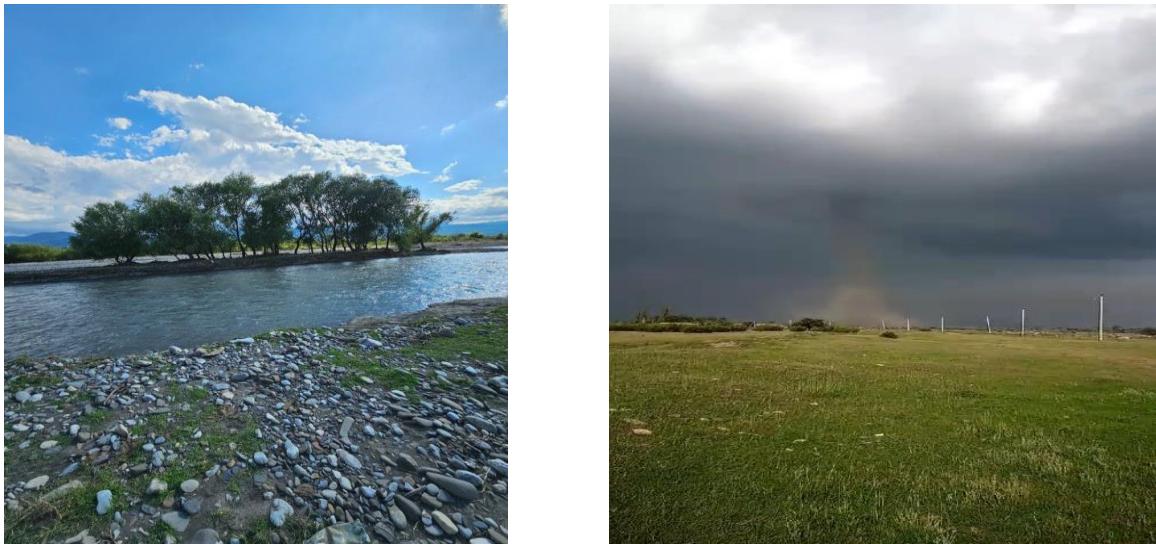
Fig. 3. Approximate location of tornado origin. On the left is our photo, on the right is a still from the video of farmer Khvicha Chikhoshvili.

According to an eyewitness, farmer Kh. Chikhoshvili, it was possible to determine the approximate location of the tornado formation (Fig. 3; point 13 in Fig. 2 and Table 2).
