Complex Research of Concrete Structures with Ultrasound and Geolocation Methods

The subject of our research was to study the current state of the Tsageri catchment, using georadiolocation and ultrasound methods. Georadar Zond 12e was used in the research. Georadar data were collected and processed with Prizm 2.7 regular Software. With the help of georadar, it is possible to highlight voids, cracks and weakened environment. It is also possible to determine the degree of humidity of the environment. Antennas of different frequencies are used to study different environment. By our research was used 1 MHz, 1.5 MHz and other frequencies antennas. Ultrasonic method is also an effective tool for determining the mechanical parameters of the environment and its structure. In the presented works, the ultrasonic equipment manufactured by the Swiss company PROCEQ, pulsed echo transmitter - Pundit PL-200PE was used. Processing of the obtained material was performed by means of the Pundit - 200 and Pundit - 20PE working program "PL-Link". Using ultrasonic equipment, it is possible to highlight voids and cracks in the environment and study their geometrical parameters, as well as determining the

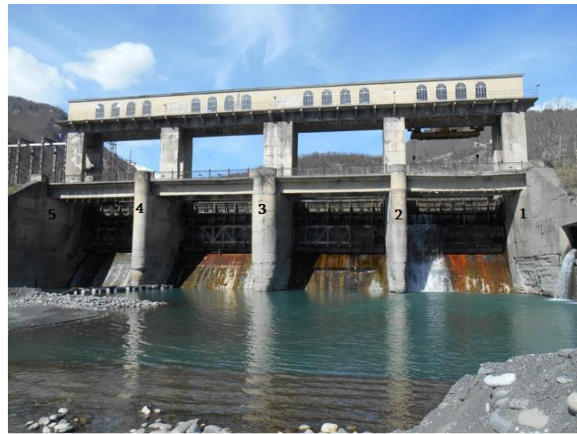
Ultrasound examinations were performed on the load-bearing piers and walls of the Tsageri catchment (Fig. 1). Approximately 100 sites were selected in the vertical direction on the walls of the building where the mechanical properties of the concrete were studied.

Fig. 1. a) Tsageri catchment. 1 - East wall, 2 - First (east) pier, 3 - Second (central) pier, 4 - Third (west) pier and 5 - West wall. b) A picture of the ultrasound work on the load-bearing piers and walls of the catchment dam.

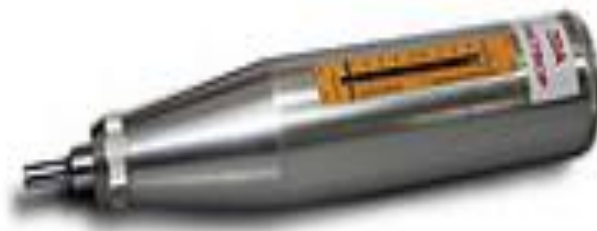
Fig. 5. The appearance of the Schmidt hammer.

The physical basis for the operation of this device is based on the amplitude of its reflection (recoil) when a solid body is struck by a solid surface. Accordingly, the greater the density (strength) of concrete, the greater the amplitude of its reflection and the data on the scale.

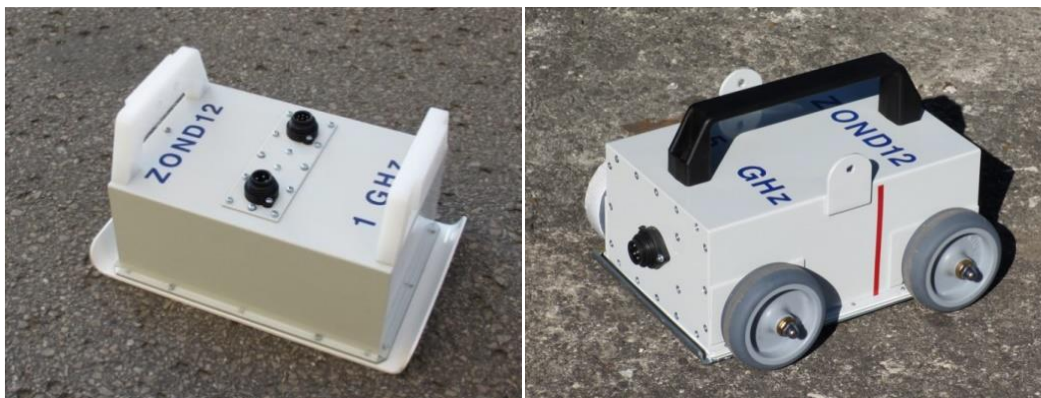
Fig. 7. 1 GHz antenna and 1.5 GHz antenna with its own odometer wheel.

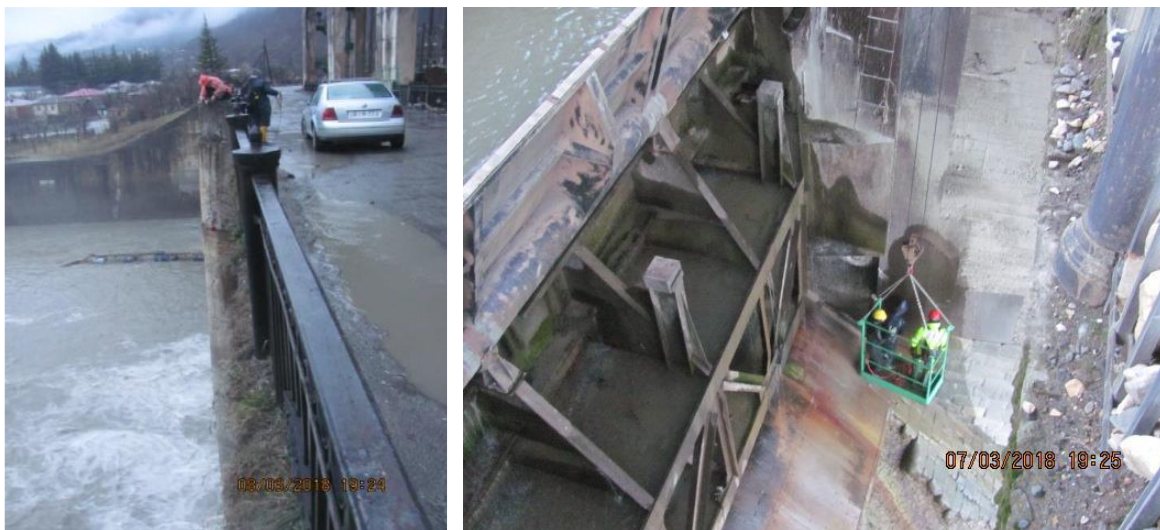
Fig. 8. a) Georadar research process along the second pier (using 1000 MHz antenna), b) low-threshold dam condition investigation process using 1000 MHz antenna.

During the georadio-radar profiling of the low-threshold dams located at the base of the first and second barrier shields, the geophysical team, with the help of a crane, descended to the level of the dam and moved the 1000 MHz antenna along the inclined surface from the ground up, along its entire length, by means of a designated cable-rope with markings of meters (Fig. 8).

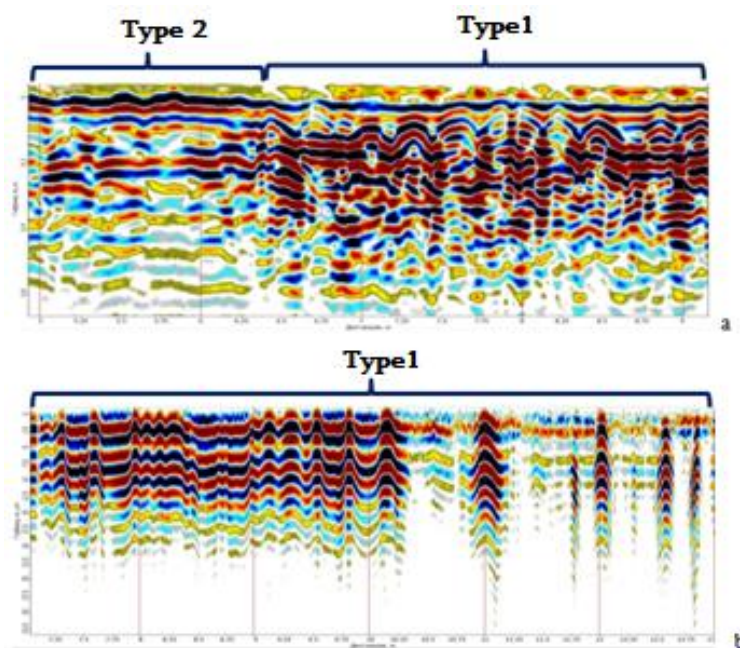
According to the type of arrangement of reinforcement rods, two types of reinforcement were identified: walls (a) and piers (b) Fig.9). The first type of reinforcement is characterized by the arrangement of small-diameter iron reinforcement rods close to the surface in the form of a grid (type 1). This type is typical for the concrete slabs on the walls and the sections towards the bottom of the pier.

The second (type 2) is characterized by an irregular and deep placement of the reinforcement rods. The amplitude of the change of the EM wave field on this type of constructions is characterized by low intensity, technological boundaries, flaws and layering will be observed in the concrete structure.

Fig. 9. Fragments of geolocation slices obtained with the help of 1000 and 1500 MHz antennas. The drawing shows two types of reinforcement of concrete structures: eastern wall (a) and piers (b).

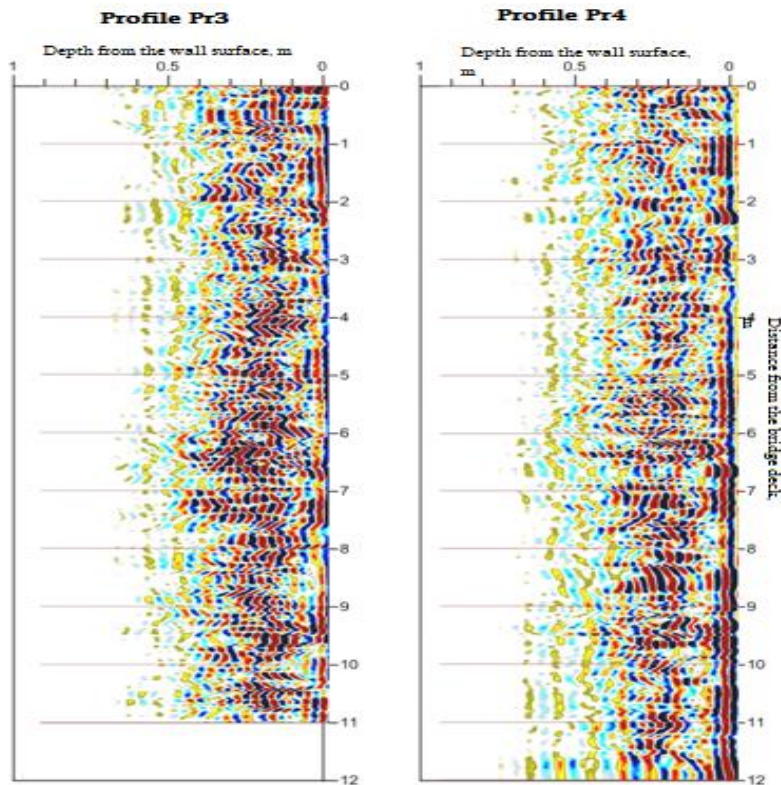
Corresponding reinforcement types (1 and 2) were not identified on the profiles (Pr3 and Pr4) obtained for the above-water sections of the first pier. Depending on the nature of the wave field, the second type of reinforcement can be seen here.

Fig. 11. Georadiolocation slices Pr3 and Pr4 obtained along the first pier.

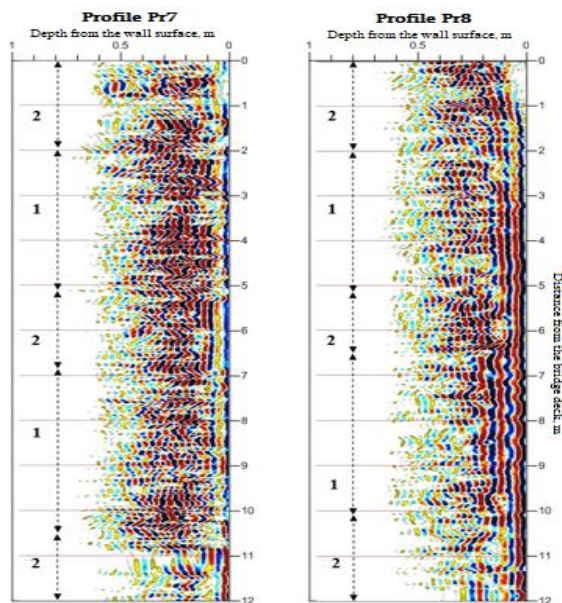
Sections of type 1 and 2 reinforcements are separated by vertical arrows Pr7 and Pr8 along the georadiolocation slices taken along the surface of the third pier's above-water part. The types and intervals of these reinforcements are almost similar to the results of the survey of the second pier (Fig. 13).

Fig. 13. Georadiolocation slices taken along the third pier (Pr7 and Pr8).

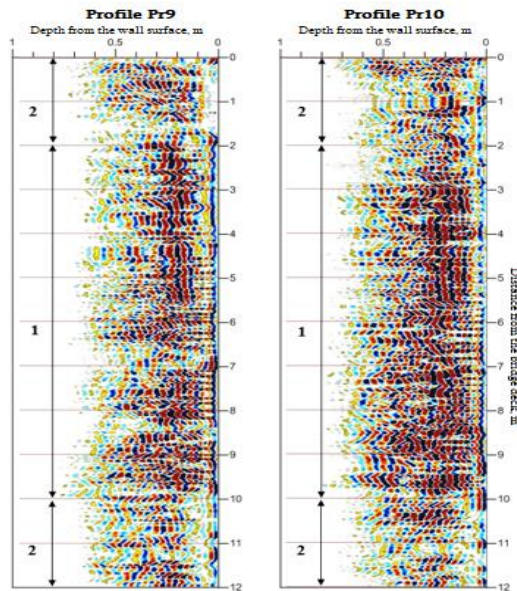
On georadiolocation slices (Pr9 and Pr10) obtained during the survey of the above-water part of the western wall, the reinforcement intervals of type 1 and 2 were well distinguished. They are separated by vertical arrows (Fig. 14).

fig. 14. Types of reinforcement found along the western wall along Pr9 and Pr10.
