The Impact of the Earthquake in Racha on the Enguri Arch Dam and the Adjacent Area

ABSTRACT

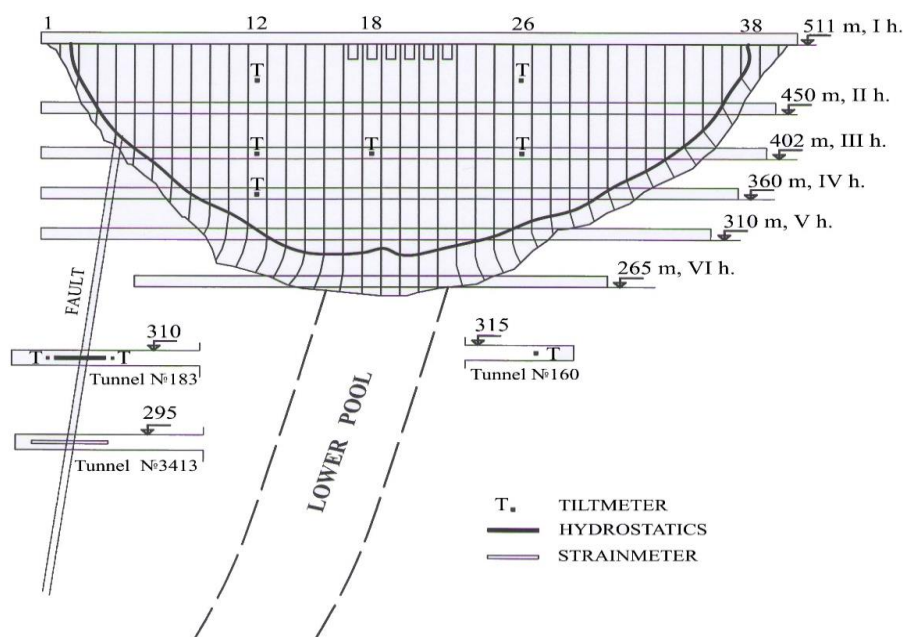
Fig. 1. The layout of the geophysical stations installed on the body and foundation of the Enguri Arch Dam.

As shown in the Fig. 1, the observation points are located at elevations of 360 m, 402 m, and 475 m in the 12th and 26th sections, as well as at the 402 m elevation in the central 18th section. At each point,
